STRUCTURAL CONDITION SURVEY

LAND REUTILIZATION AUTHORITY
OWNED PORTION
of
CARTER CARBURETOR FACILITY
ST. LOUIS, MISSOURI

JULY 1995

**TapanAm Associates, Inc.
Leawood, Kansas and
Kansas City, Missouri
For
U.S. Environmental Protection Agency
Region VII
Kansas City, Kansas**

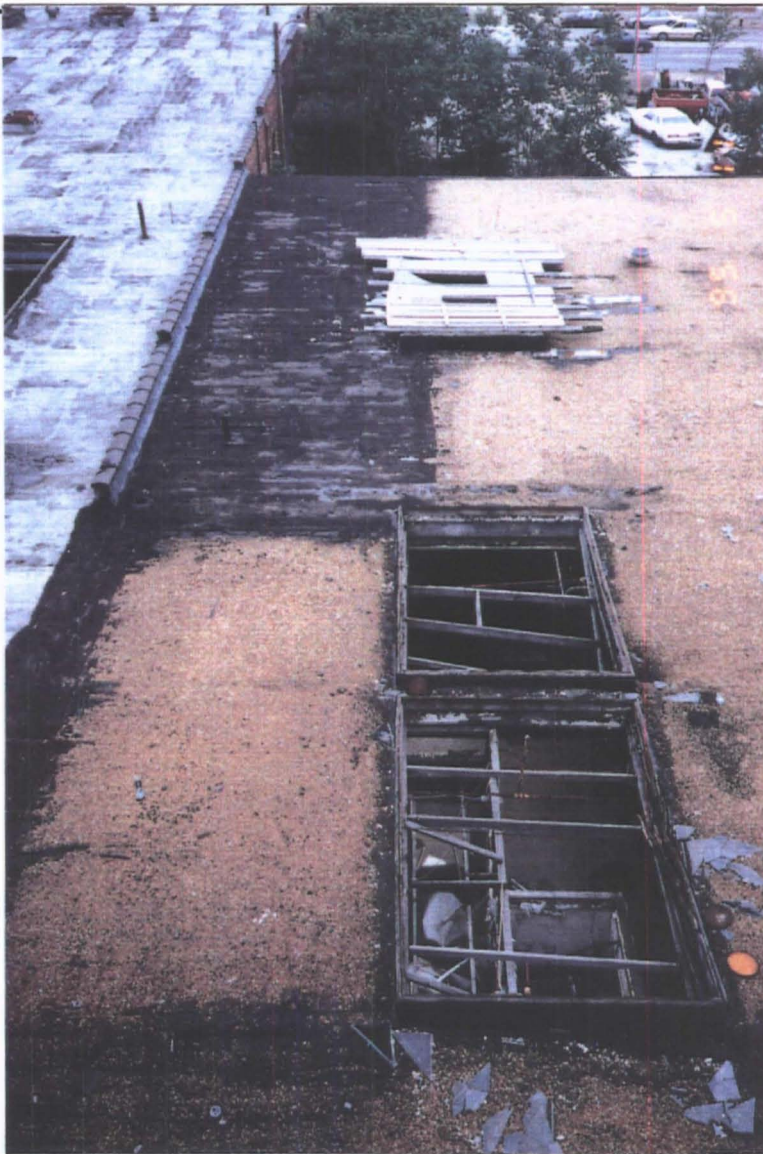
No. 21

Skylights penetrate the roof with the glass missing and exposing the underside of the roofing substrate and framing and the interior to the elements. Evidence of deterioration was observed in the vicinity of the openings for the skylight and collapsed area of the roof. Interior damage is accelerated due to the continual exposure to rain, sleet, ice, or snow throughout the year. (Photo Nos. 21 and 22)

Warehouse/Office & Shop: Existing skylights with wireglass glazing broken out

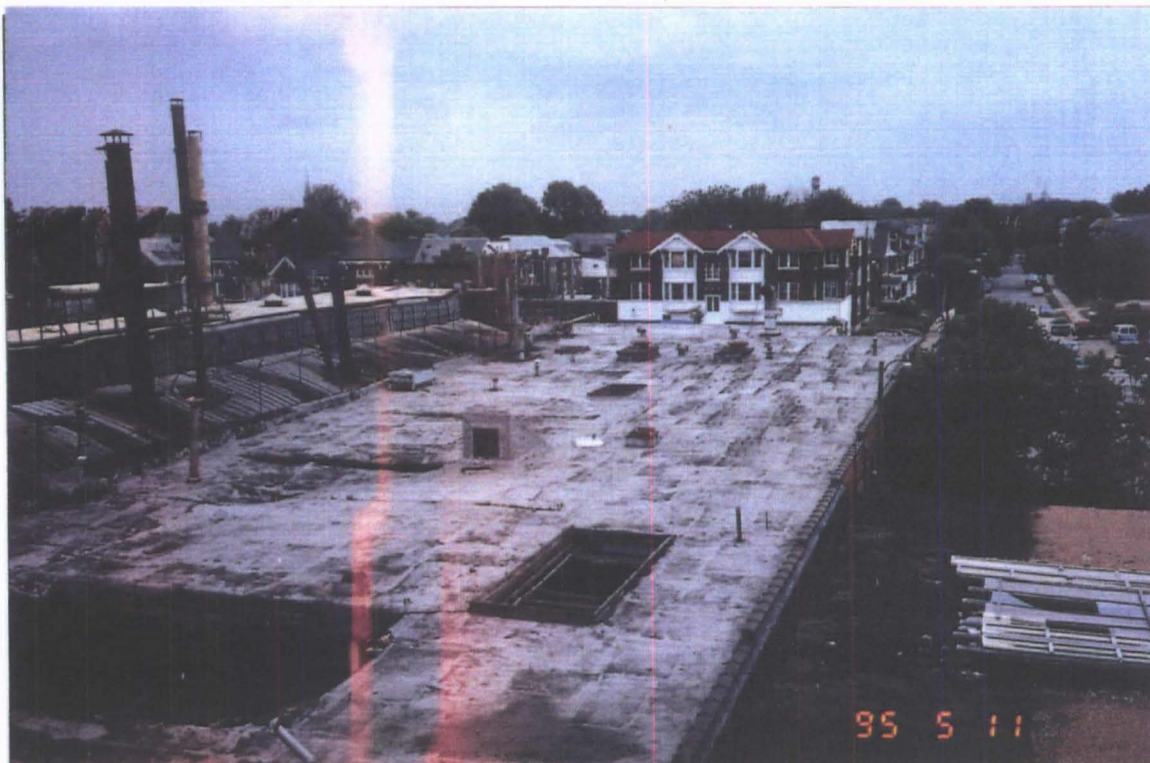
No. 22

Warehouse/Office & Shop: Collapsed areas of roof
